The crypt of St Mary-le-Bow Conservation Management Plan

John Schofield and George R Bush

September 2007

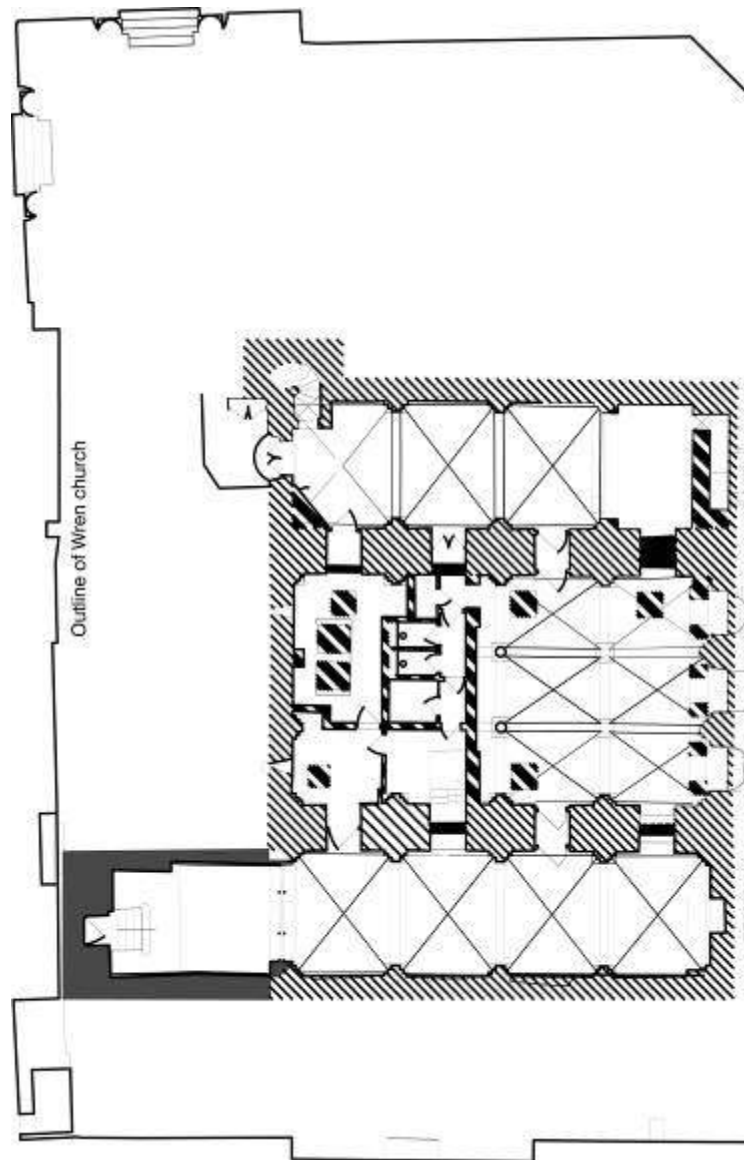
Fig 1 The areas of the crypt and the Wren church compared (from the MoLAS survey, 2006; given in detail in Fig 3)

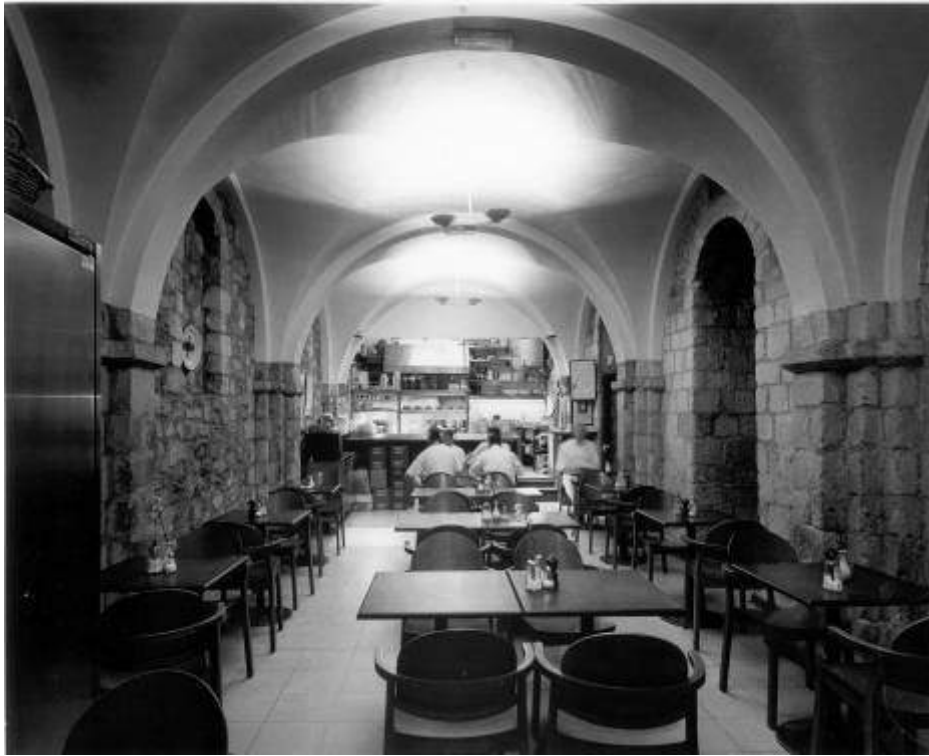
Fig 4 The north aisle of the crypt, looking east (© Crown Copyright, NMR)

The north aisle which houses the restaurant is shown from the west in Fig 4; and a view of the central nave, the Court of Arches area which is also used by the restaurant, from the south, in Fig 5.

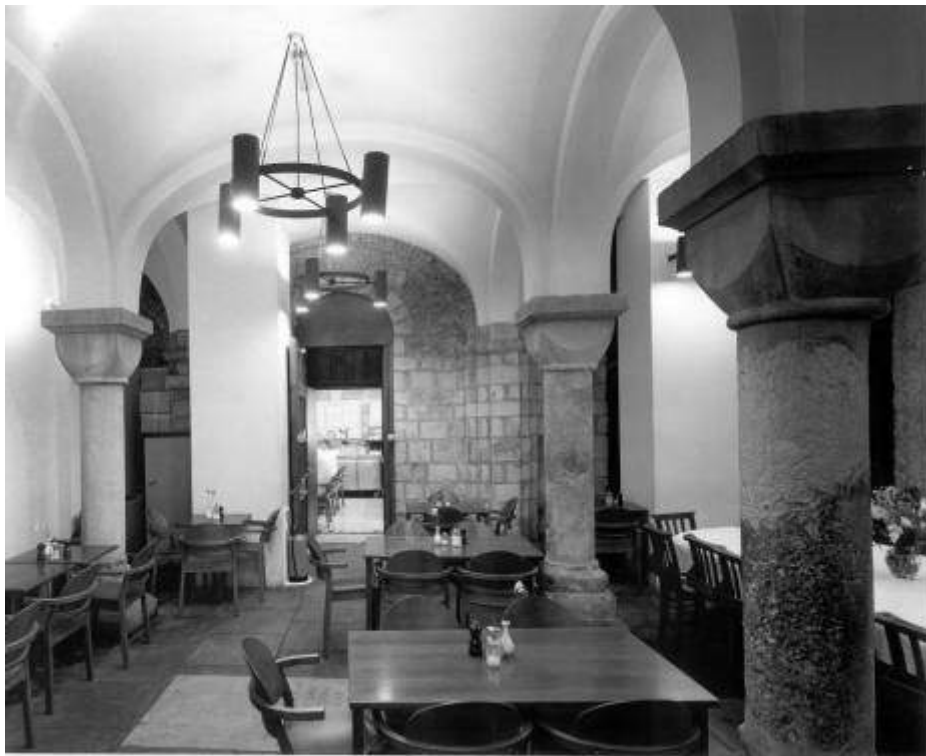
Fig 5 The east part of the crypt, lately used as the Court of Arches, and daily as part of the restaurant, looking north (© Crown Copyright, NMR)

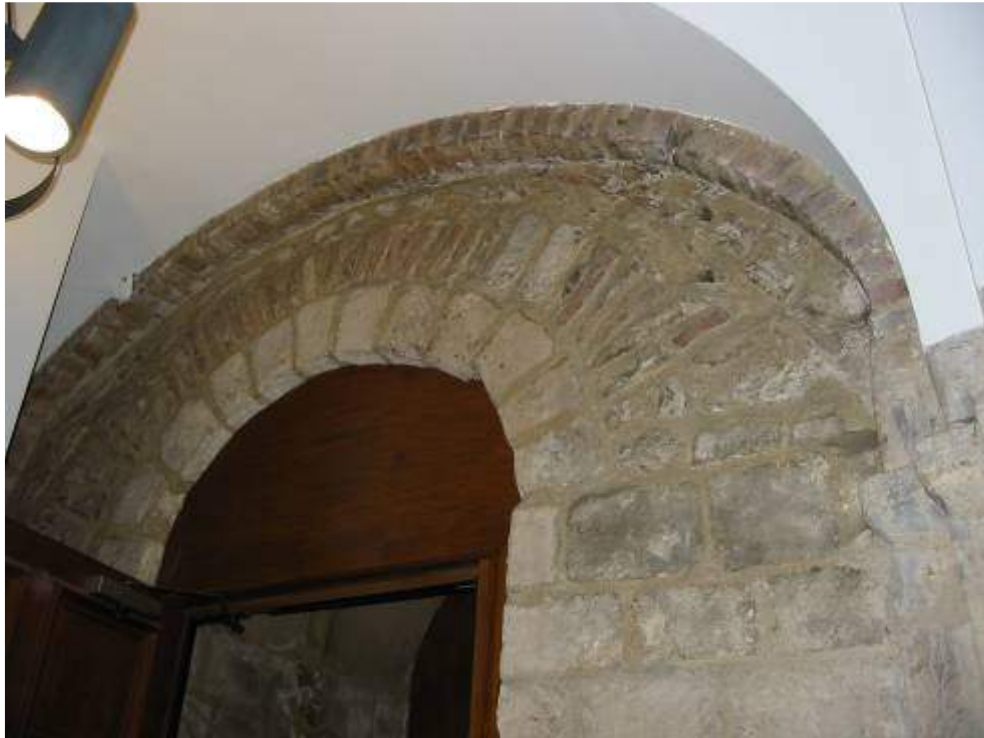
Fig 8 Roman bricks used above the second arch from the east in the north arcade, from the south (i.e. the Court of Arches)

mostly been repaired, but they were probably also in squared ashlar voussoirs, in some cases with arches of Roman brick above (Fig 8). All the walls have been repointed, most recently in the 1960s, with a mortar which is hardly appropriate in appearance.

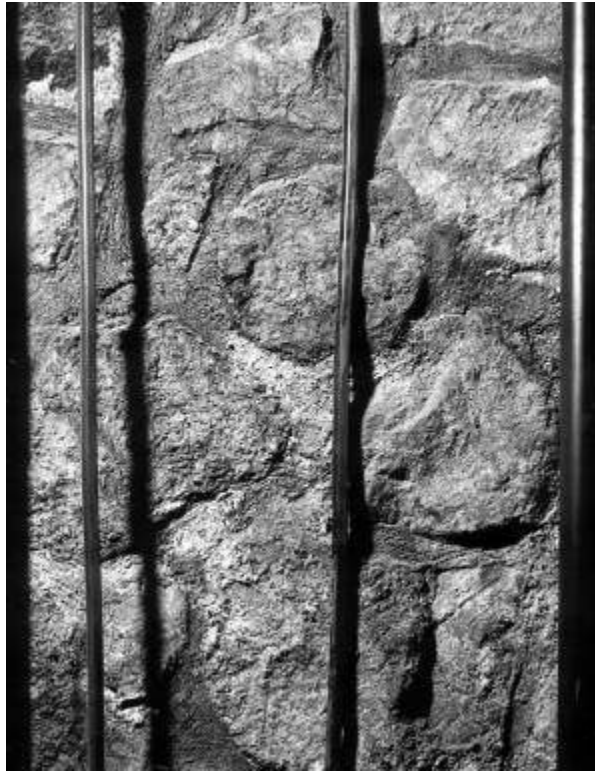
Fig 9 Three circular stones in the west wall, which look like reused columns, perhaps from a demolished Roman building (© Crown Copyright, NMR)

In the west wall, in the comparatively undisturbed part now a boiler room, are three circular stones which look like reused columns (Fig 9).

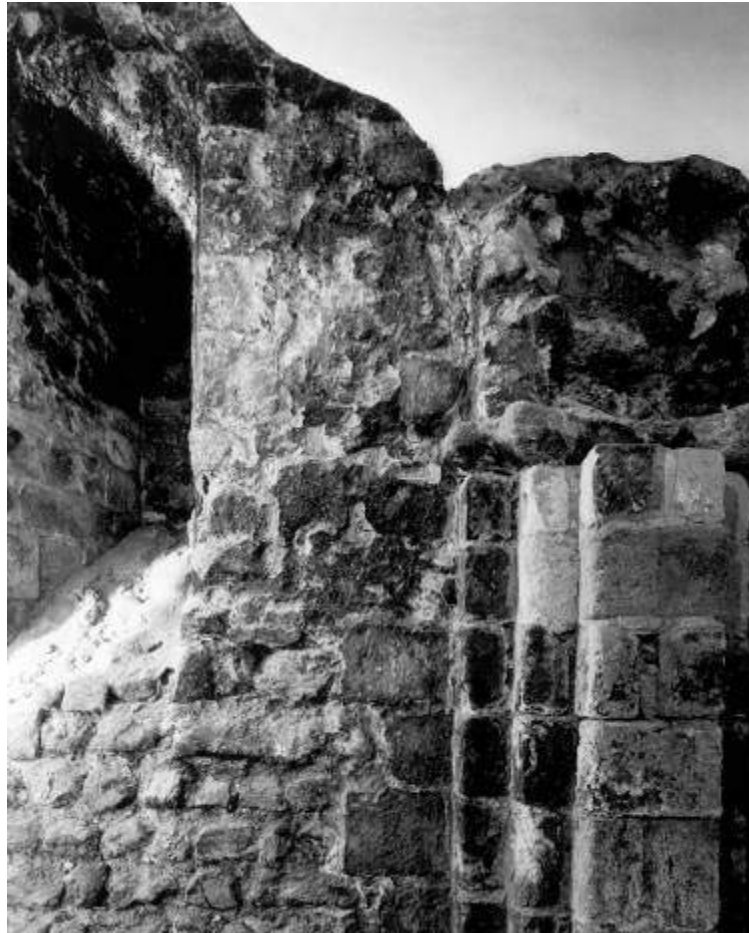
Fig 10 The west wall in the present sacristy, the west end of the nave, showing the remains of one of the window embrasures and the adjacent respond, now without its vaulting (© Crown Copyright, NMR)

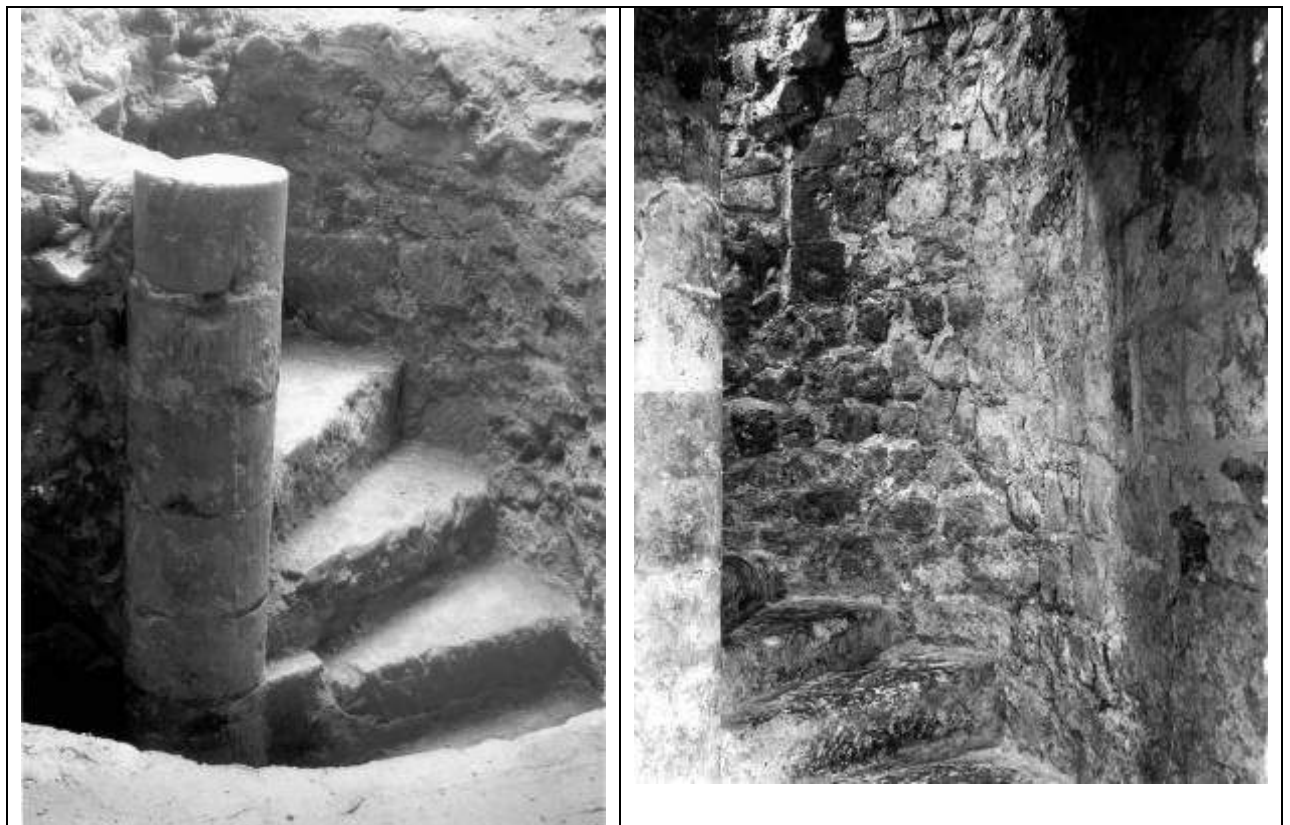
Fig 11 Two views of the spiral stair: left, as uncovered in 1959, looking north (MoL); and right, the entrance to the spiral stair today, looking north-east (© Crown Copyright, NMR)

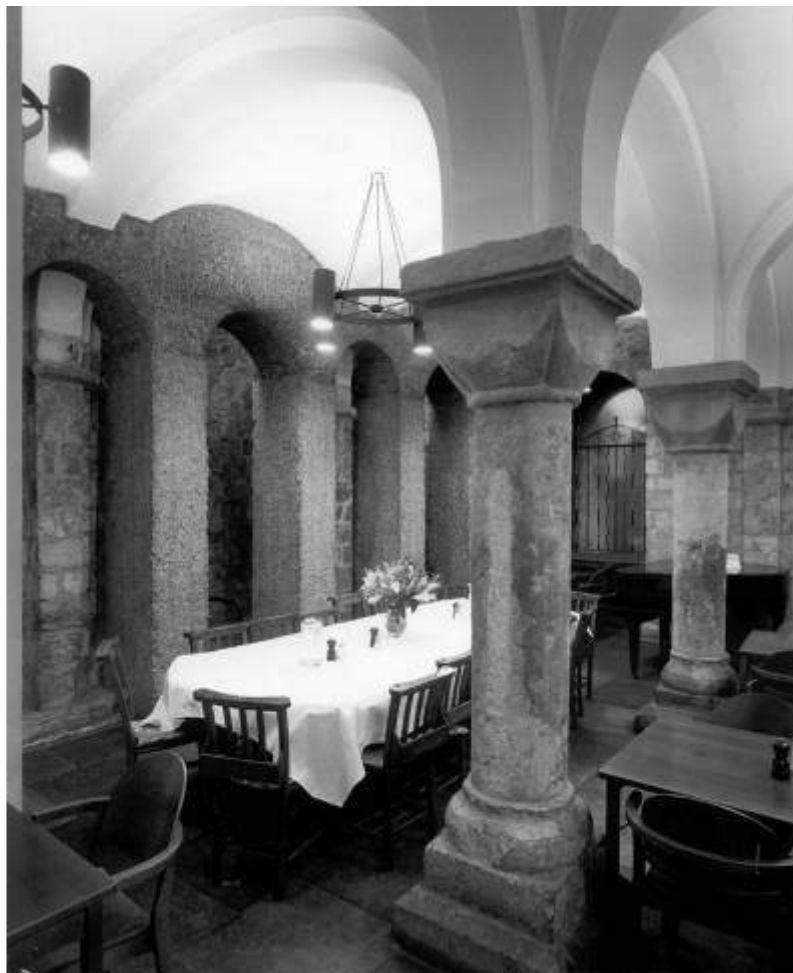
Fig 12 The east half of the nave (the Court of Arches), looking south-east and showing Columns 1 (foreground) and 2 (rear) (© Crown Copyright, NMR)

Columns 1 and 2 are original in their fabric, but an old photograph (Fig 13) seems to indicate that in both cases, the two lower blocks of the base has been replaced in the post-War rebuilding (compare with Fig 12).

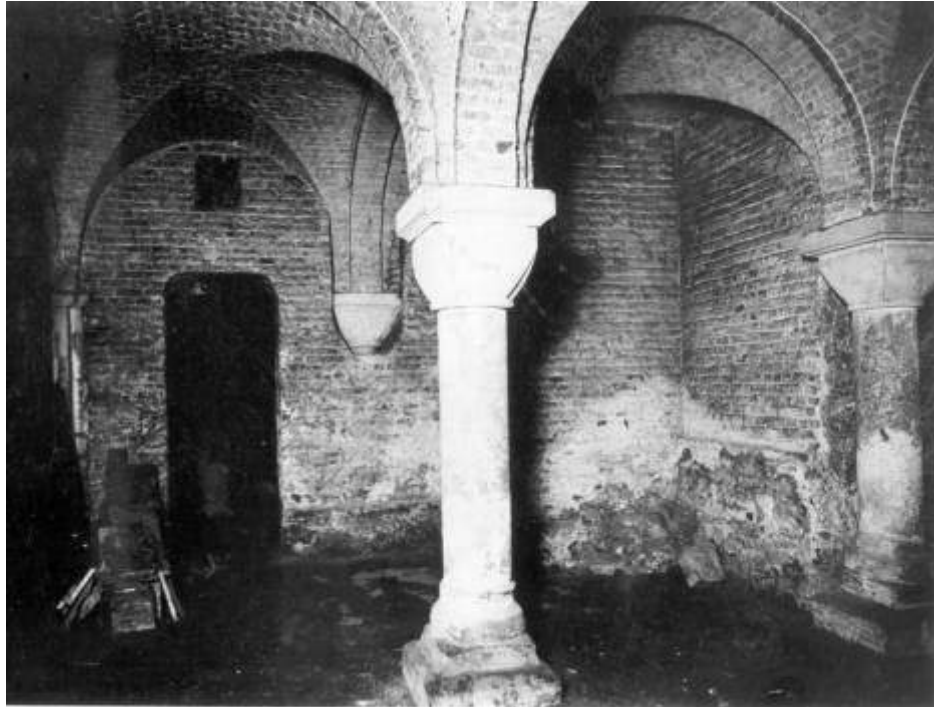
Fig 13 The east part of the nave, looking west, in the early 20th century (Guildhall Library). This shows the character of the Wren vaulting

The site of Column 3 was occupied in 1929 by a large block of brickwork, one of those put in by Wren to support the north arcade of the church above (rear right in Fig 13). It seems unlikely that he built this around Column 3 (though the RCHME survey (p.79) allowed for this possibility), and it seems probable that Column 3 is a post-War creation. Column 4 (Fig 14, its present appearance) had its column obscured by Wren brickwork; it is shown in early 20th century from the east in Fig 13. Another photograph held by the parish shows the capital and its column intact from the west; the column must be original. Bernard Worssam, in his geological report (Appendix 1, below) suggests that the plinths may be Portland Stone, in which case they are probably post-War replacements. This is the opinion of the Quinquennial Report of 2006, by Julian Harrap (below, appendix 8.2). Also notable are slight differences between the cubic capitals. Columns 1 and 2 have simple grooves at the corners, but the capital on Column 4 has spear-shapes forming the corners or arrises (Fig 14).

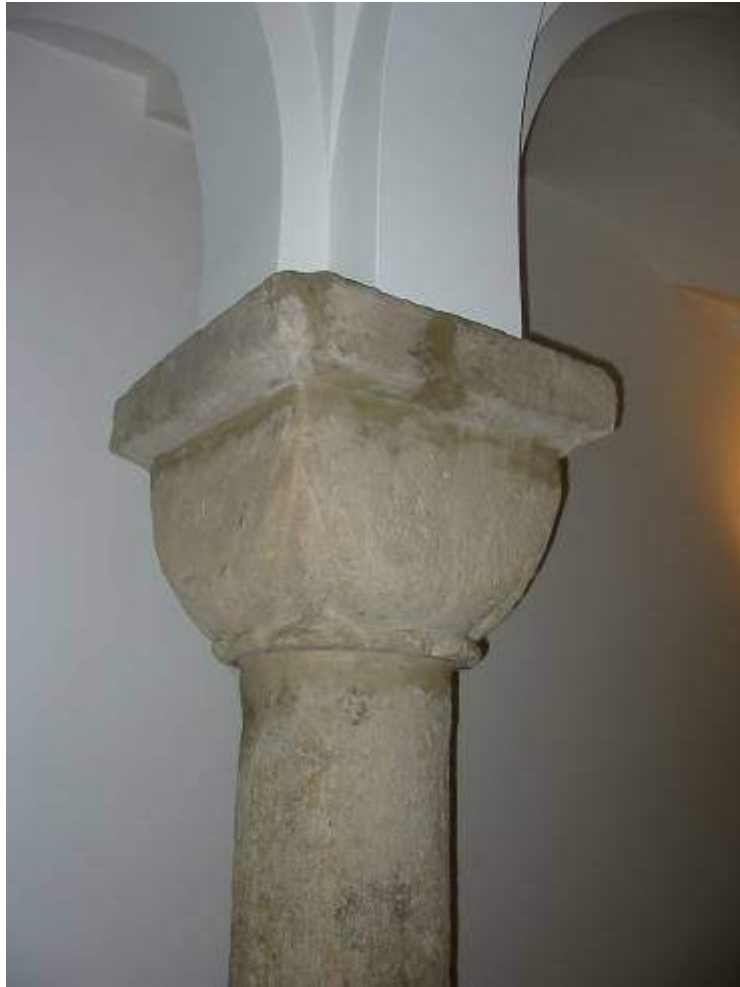
Fig 14 Capital of Column 4. The little spear-heads or leaves at the corners have so far not been noticed in other churches of this date

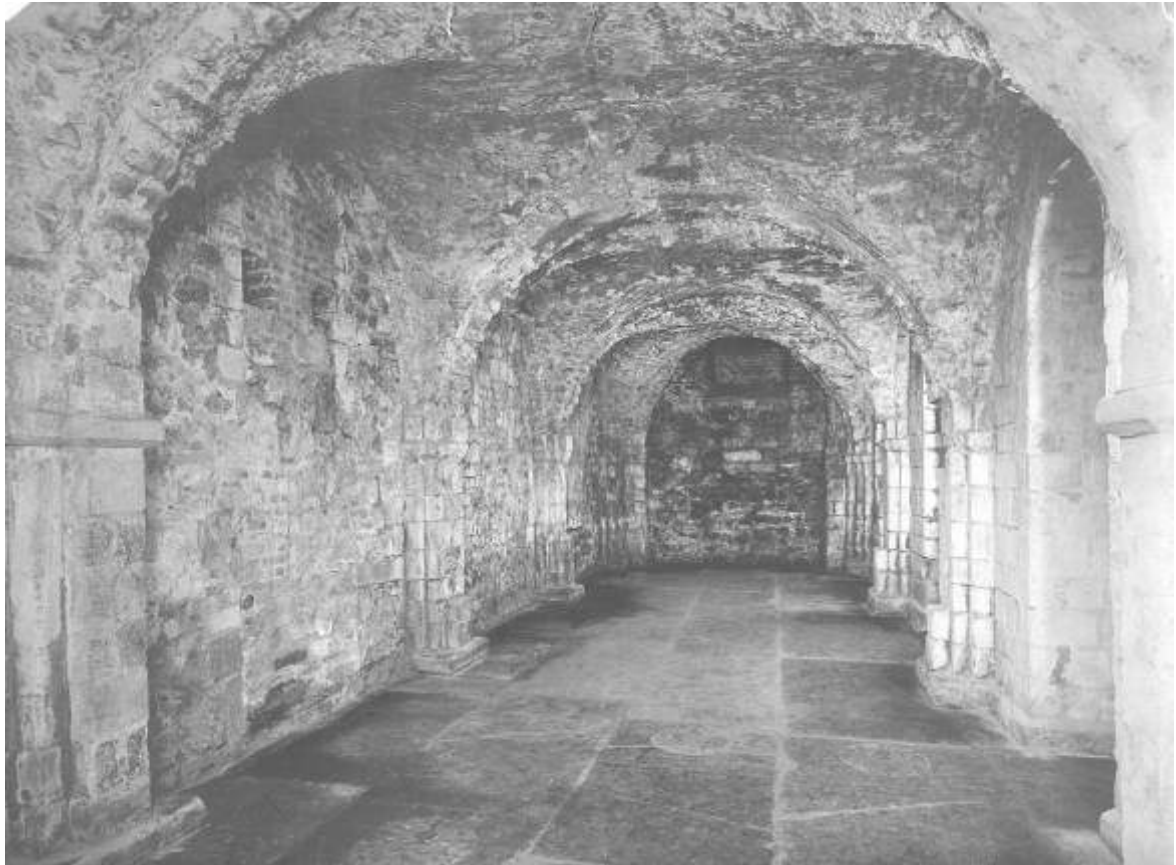
Fig 16 View of the north aisle, looking east, 'about 1931' (original now in Guildhall Library). It is believed the ledger slabs in the floor were moved into the south aisle after the War. Note the brick infilling in the embrasure, and compare with Fig 4 today. The square holes in the brick infilling were done in 1913

Fig 16 shows two features later overtaken by the post-War restoration. First, four of the responds (the second and third pair away from the camera) have most of their middle projection missing; only the bottom two stones remain. Thus the present form of these middle projections in the crypt must be post-War. Second, the walling in the bay on the left seems to show vertical lines of an opening, or patching with brick, below the window embrasure. This will be commented on below when each of the outer wall bays is examined.

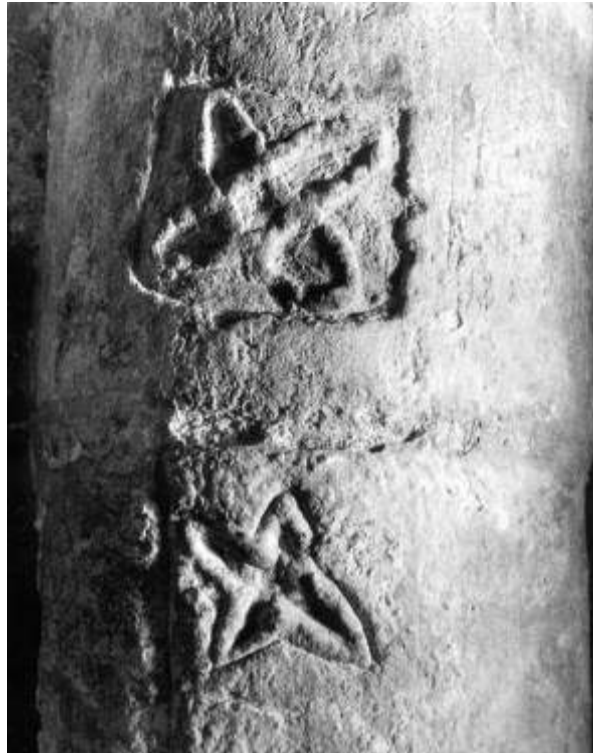
Fig 17 The incised designs on the north side of the newel of the stair (© Crown Copyright, NMR)

One intriguing and important feature of the crypt is several incised designs on the newel of the spiral stair at the north-west corner (Fig 17). They resemble the designs being cut on bone objects and perhaps on leather in the workshops in streets around the church in the 11th and 12th centuries, as found on the excavated sites such as Milk Street to the north-west. Their purpose here is unknown.

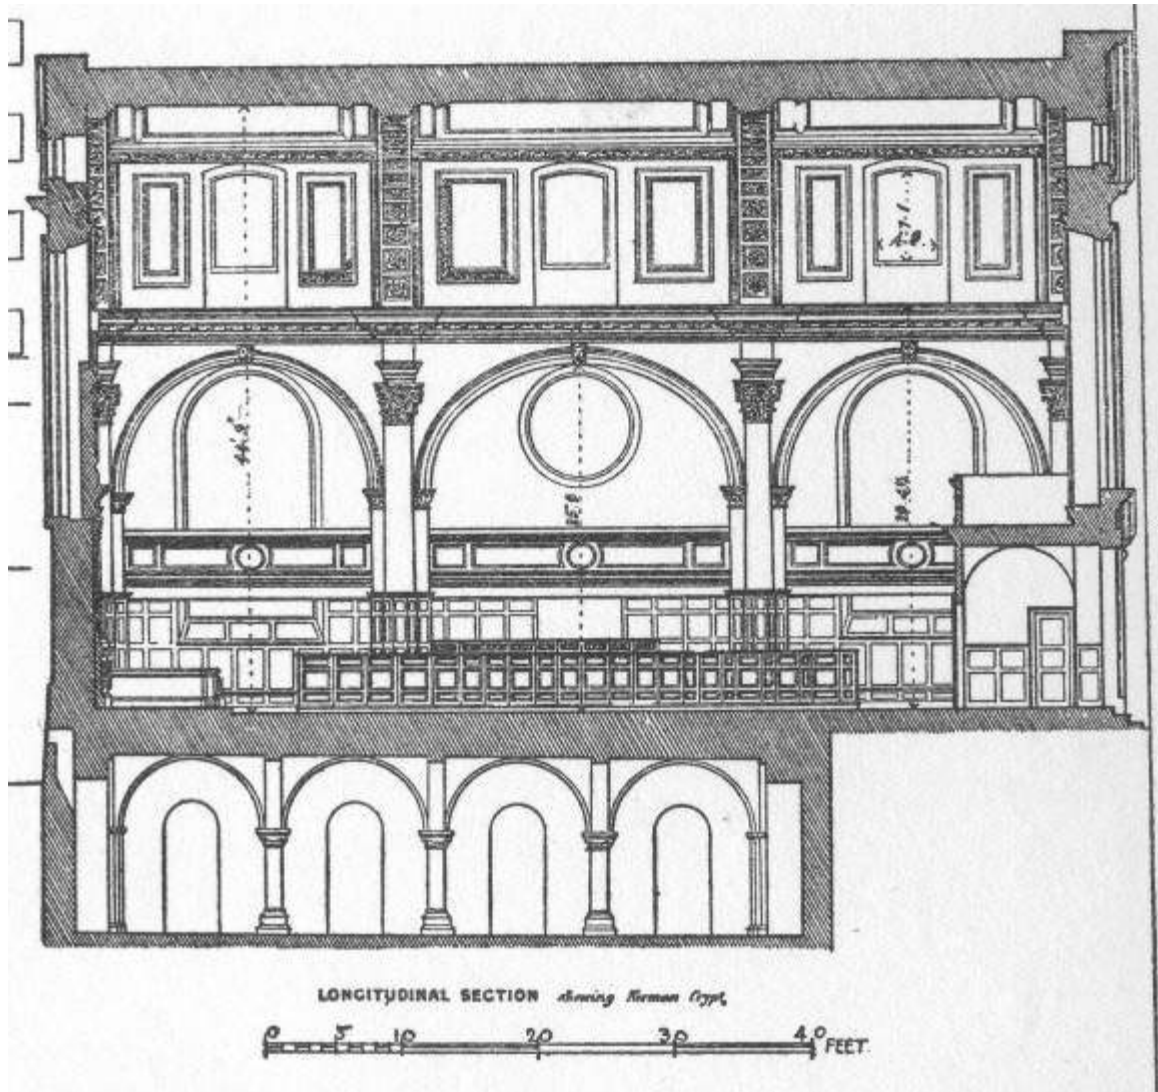
Fig 20 Section by John Clayton, c 1848, looking south (Wren Society X, 45). The line of the section is through the nave of the crypt, i.e. the central section. The columns in the crypts are 'restorations' since Wren's work in the crypt including removal of one column is not shown

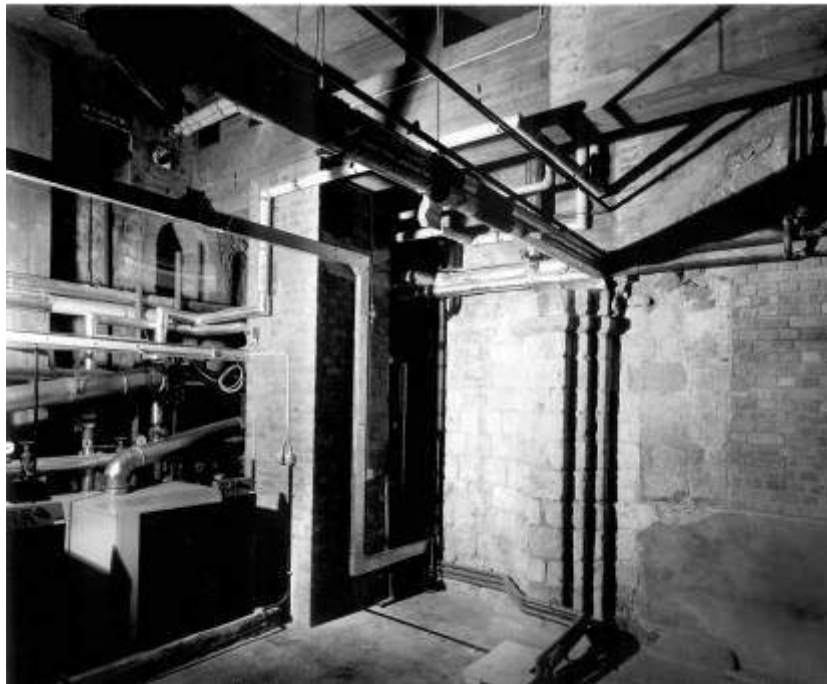
Fig 21 The boiler room in the west half of the nave part of the crypt, looking north-west (© Crown Copyright, NMR). The northern of the two surviving window embrasures can be seen in the west wall

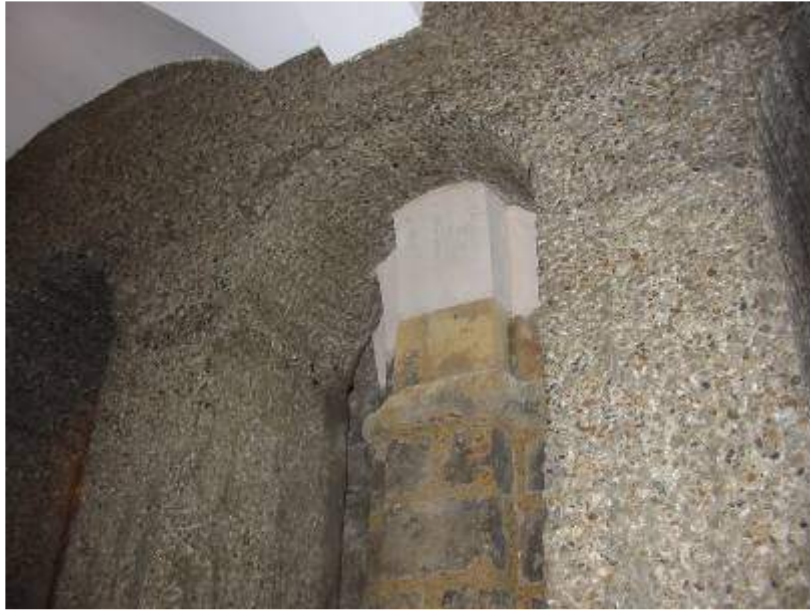
Fig 22 King's concrete arches along the east side of the main crypt chamber, with one of the 11th-century responds behind

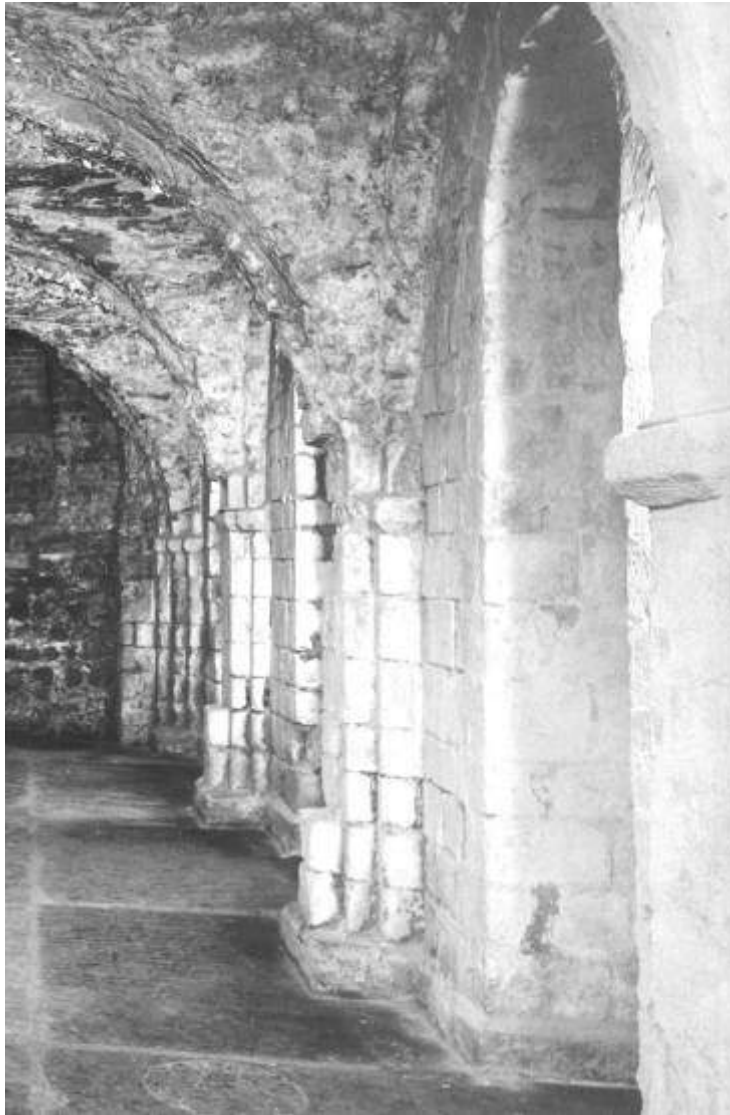
Fig 23 Detail from Fig 16, showing the south wall of the north aisle, with missing stones on the central part of both responds (the innermost order)

It is clear that King restored much of the stonework of the north aisle, but how much is very difficult to establish. One clue is afforded by the photograph of about 1930 given here as Fig 16, from which details are now given in Fig 23 and Fig 25. These show that almost every respond had some stones missing, so those now composing those parts of the responds must be post-War insertions (or at least, date from after about 1930, but 1950s is most likely). The second respond from the right (along the south side of the north aisle), shown in Fig 23, is shown in Fig 24 in its present appearance.

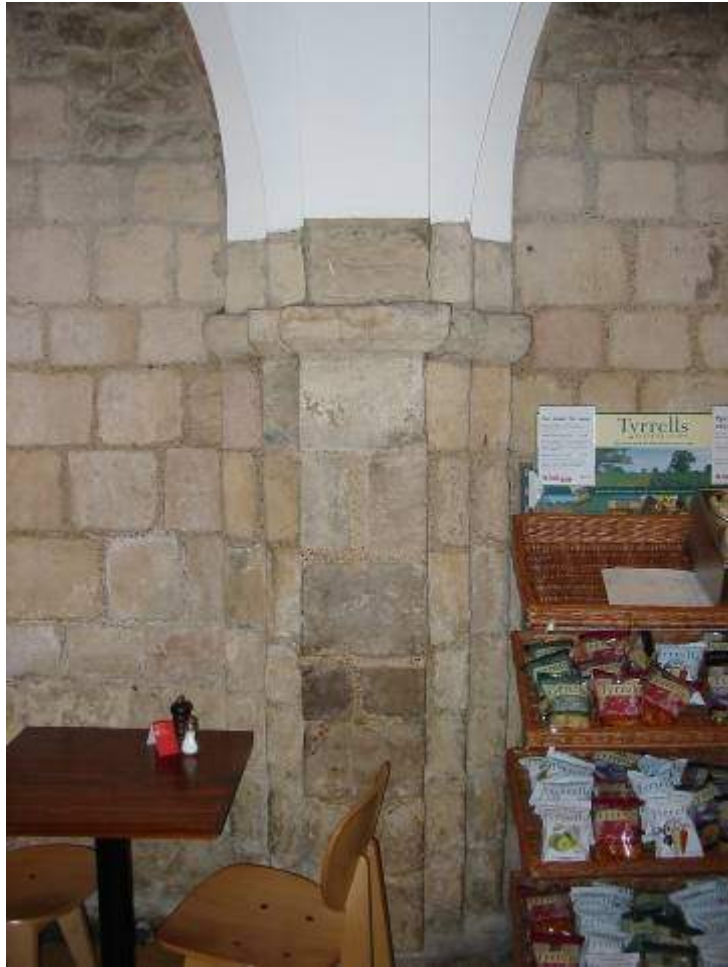
Fig 24 The second respond on the south side of the north aisle today; compare with Fig 23. Stones from the third course above the floor (level with the table top) upwards to the capital are 1950s insertions. King's new vault rises above

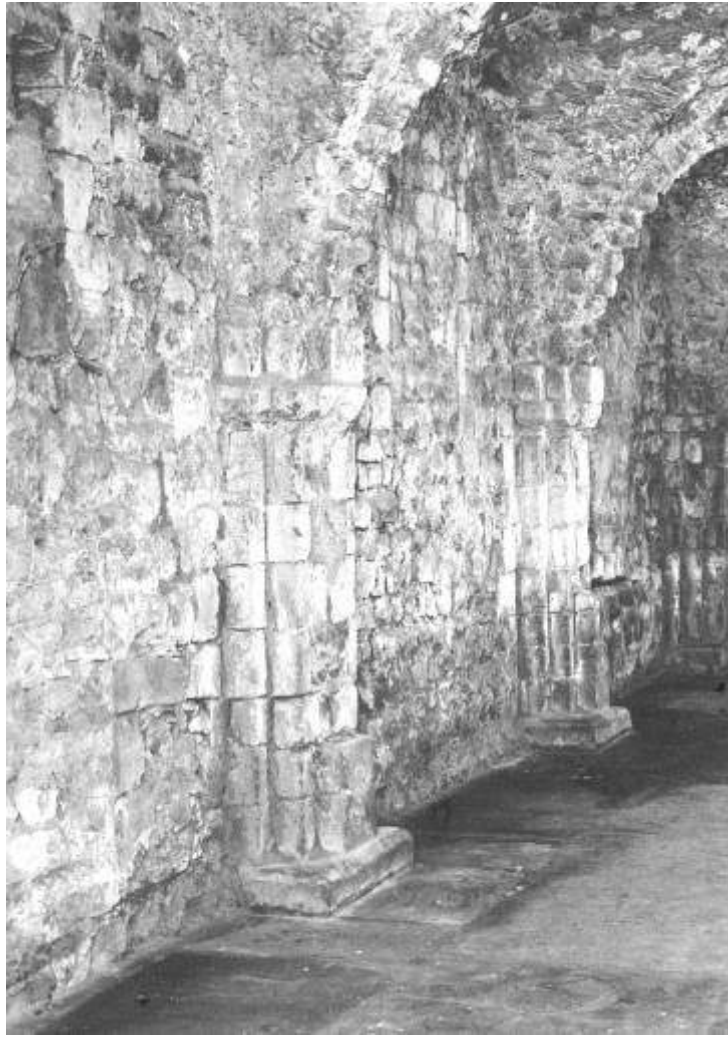
Fig 25 Second extract from Fig 16, showing north wall of north aisle, with further examples of missing stones on the responds

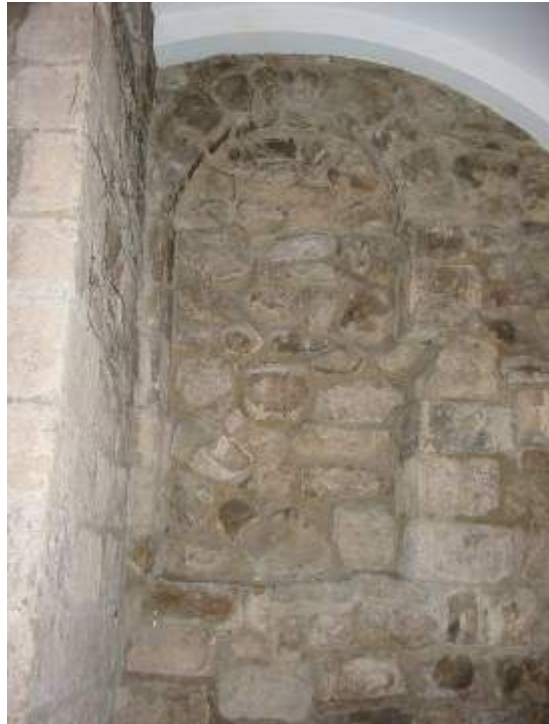
Fig 28 The north wall in Bay 2

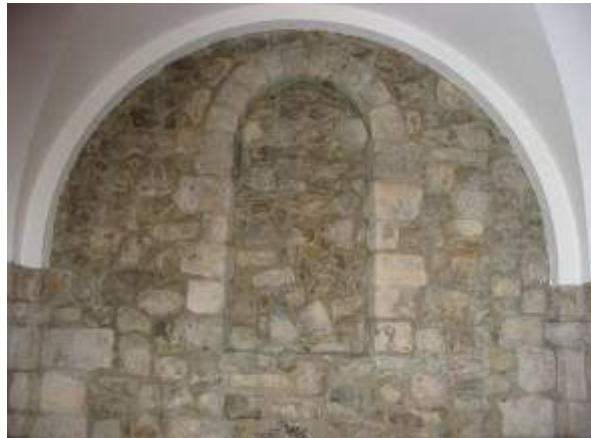
BAY 2

Bay 2 has a window embrasure. This is shown in the pre-War photograph Fig 16, though it was then filled with brick. The vertical lines then below the window are not presently explained; their traces were removed by King.

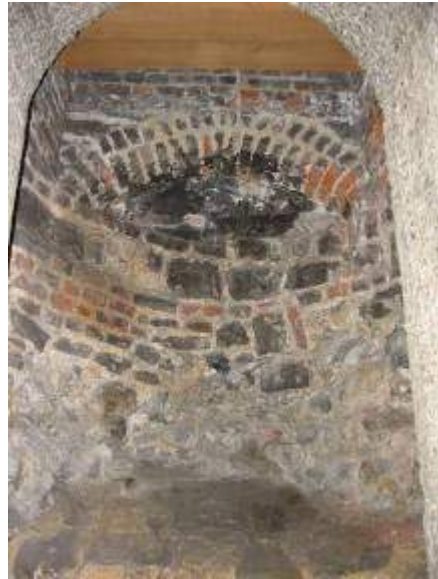
Bay 6 forms the northernmost of the three bays in the central nave chamber of the crypt. The recess (Fig 29) is a conglomerate of original 11th-century work, including traces of a ?window sill towards the bottom, and 17th- to 19th-century brickwork above.

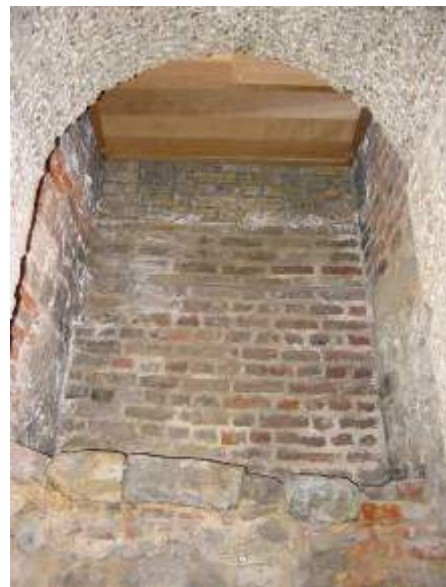
BAY 7

The recess in Bay 7 (Fig 30) also has the remnants of the sill of a former opening (an entrance or a window?), but the walls of the opening are mostly formed by 18th- or 19th-century brick. Beneath the church floor, several courses of 1960s brick. It is possible that there was an entrance here in Gwilt's time

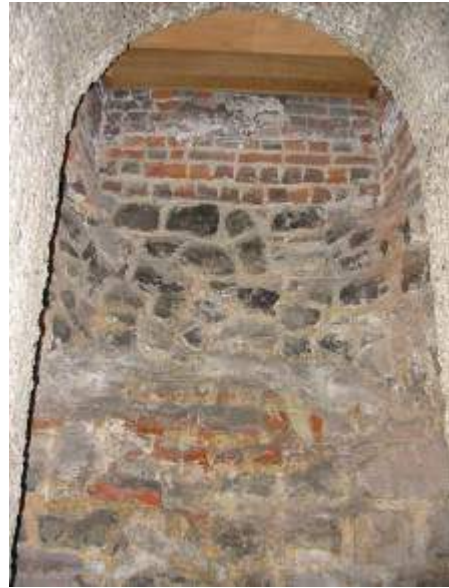
BAY 8

The recess in Bay 8 (Fig 31) has no evidence of a window, though presumably there was one originally. Like the other recesses of the east wall, it is heavily altered with 18th- and 19th-century brickwork.

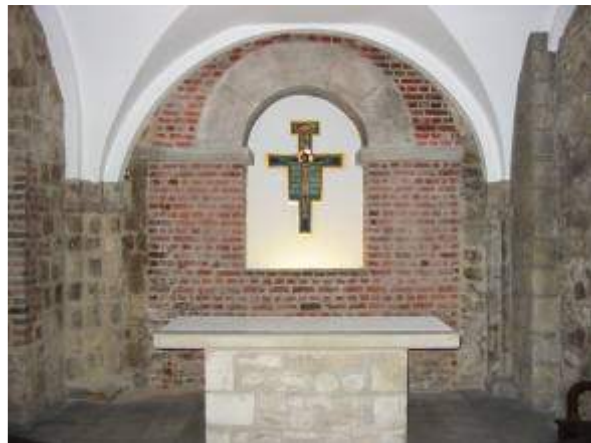
BAY 9

Bay 9 is the wall forming the east end of the south aisle (Fig 32). The bay is occupied by a brick wall, with stone arch above. The present survey has no evidence for the date of this feature; the arch must be post-War, but the bricks are older, and the bay is shown blocked in the RCHME plan of 1929 (Fig 15). So perhaps the arch has been inserted into an existing, older brick wall

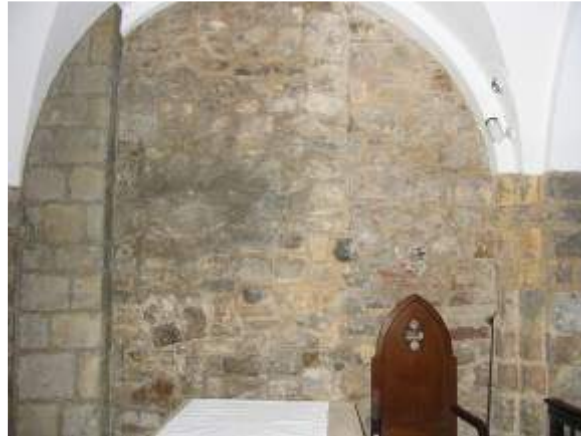
Fig 34 Bay 11, looking south

Bay 11 has two vertical lines in its masonry (Fig 34). There is the start of a chamfered jamb about 0.86m west of the respond forming the east side of the bay, and a further vertical line of stones which have 18th-century bricks to the west. This looks like there may originally have been a window in this bay.

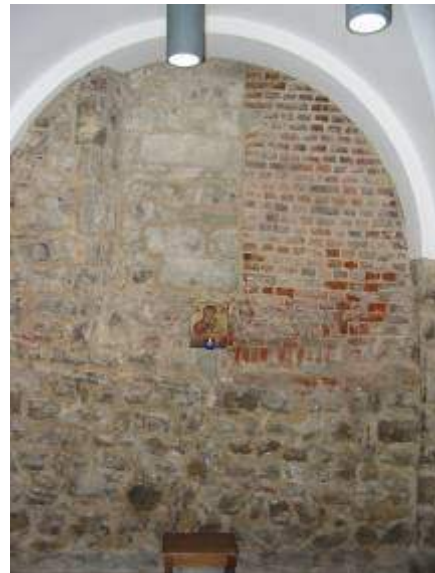
Fig 35 Bay 12, looking south

Bay 12 has a chamfered recess in it which looks like a medieval window or possibly a doorway (Fig 35). This is 1.36m wide.

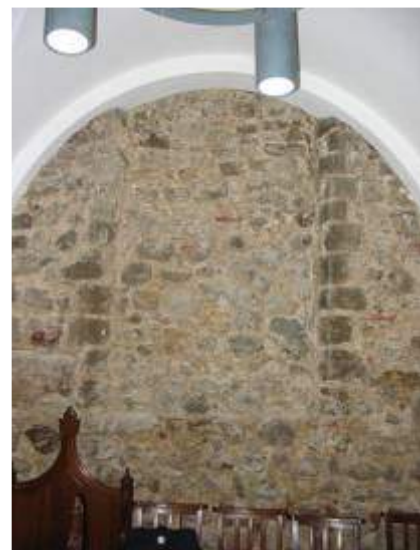
Fig 36 Bay 13, looking south

Bay 13, the westernmost bay of the south wall of the 11th-century undercroft, contains an opening 0.76m wide now filled with 18th- or 19th-century brick (Fig 36). This is to one side, not in the middle of the bay

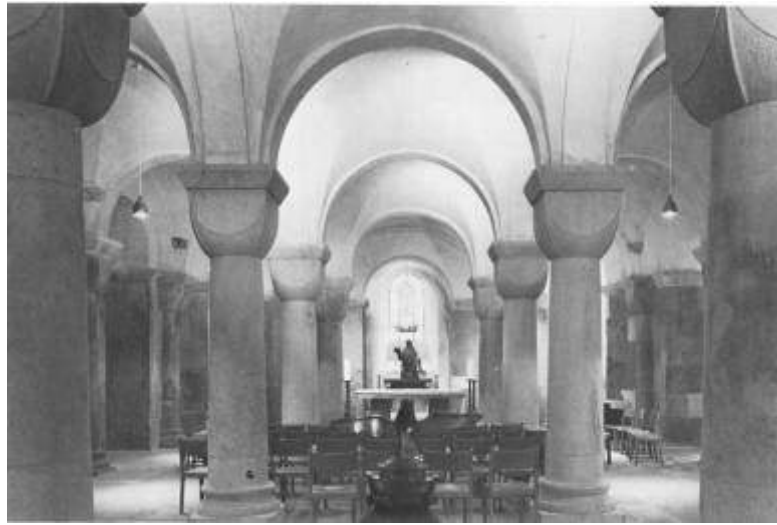
Fig 39 The crypt of St Maria im Kapitol, Cologne, of around 1045–9, looking east (Binding and Kahle 1983, fig 59)

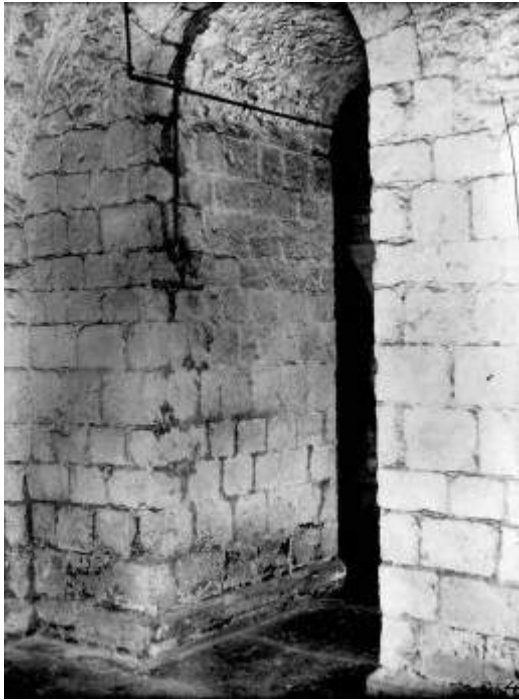
Fig 41 A pre-War photograph of the arch in the north arcade now forming the entrance to the nave from the north aisle, showing the pointing of the stones (Guildhall Library); compare with Fig 42

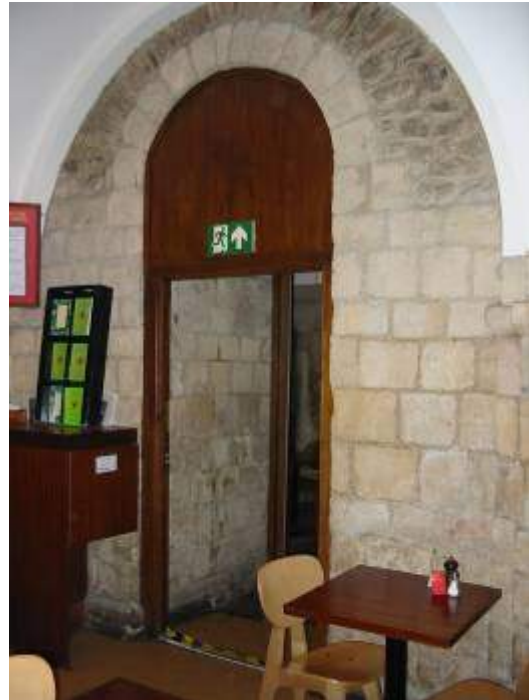
Fig 42 The arch comprising the entrance from the north aisle to the central nave today; compare with Fig 41

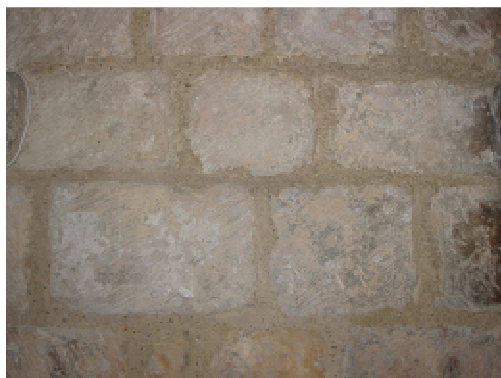
Fig 43 An example of the bad pointing; the corners or arrises of the stones are obscured by too much mortar

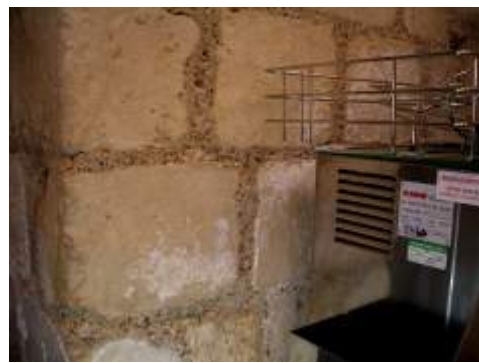
Fig 44 The mortar is mostly of this speckled, gritty character. Here also is an example of the salts coming through

There is a particular problem with the walls of the crypt: chemical changes to the surfaces at various points in two ways, the production of white crystalline salts, and the crumbling of old bricks into dust. These two forms of efflorescence have been noted in virtually all the internal spaces. Efflorescence on stone walls is commonly attributed to repeated wetting and drying cycles, which lead to powdering and fragmentation (Ashurst and Ashurst 1988, 3).

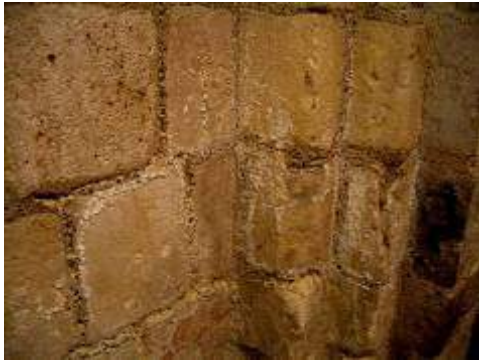
Fig 45 Another example of the salts

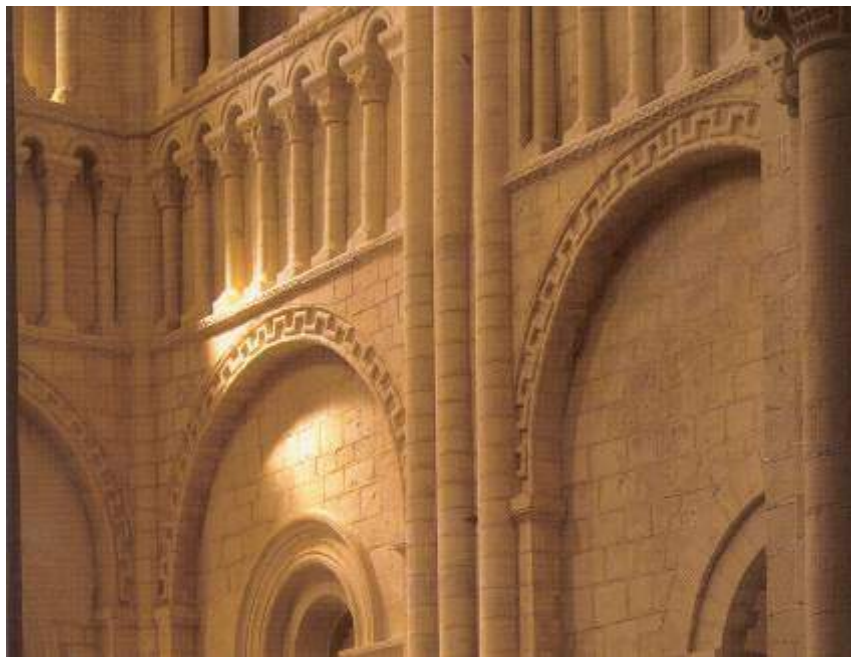
Fig 46 A detail of the south transept of the church of Abbaye aux Dames, Caen (Calvados, Normandy), showing how Caen ashlar is pointed today
